ADF&G TECHNICAL DATA REPORT NO. 106  
(Limited Distribution)

## REVISED ANADROMOUS STREAM CATALOG OF SOUTHEASTERN ALASKA

District 106

North Prince of Wales Island

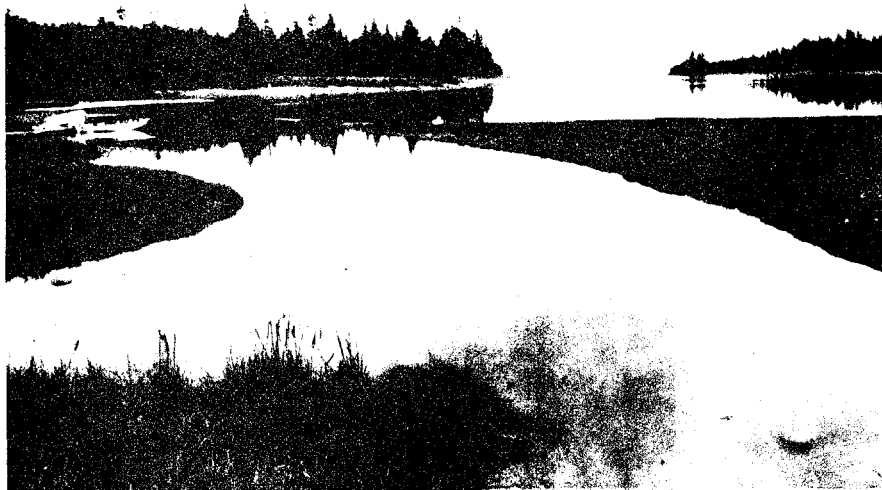
1. Lower Intertidal Area Looking out to Sumner Straits and the Mouth of Red Bay (North End of Bell Island on Left.)

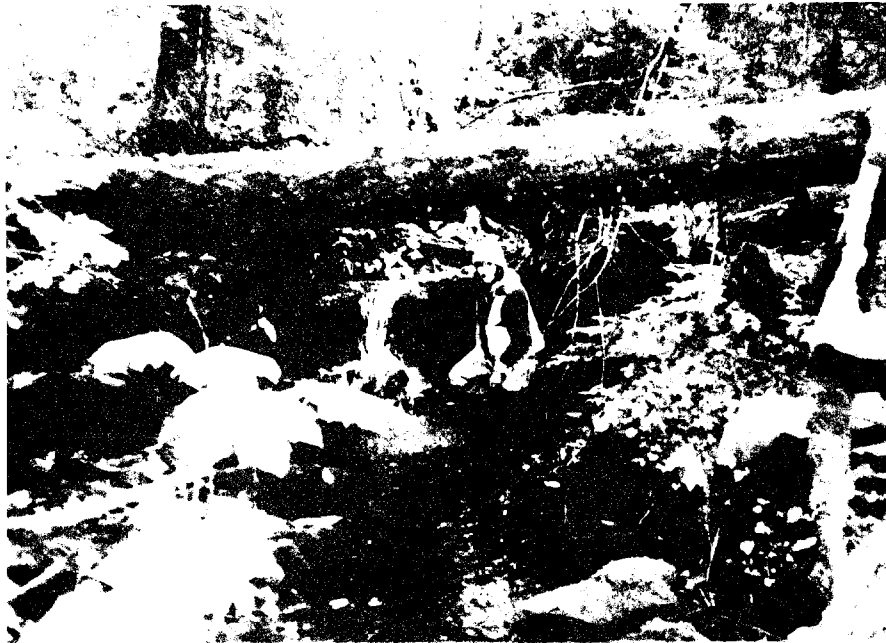
6. Section 4: Three Foot Falls Over Sunken Debris;  
Common Throughout Survey Area.

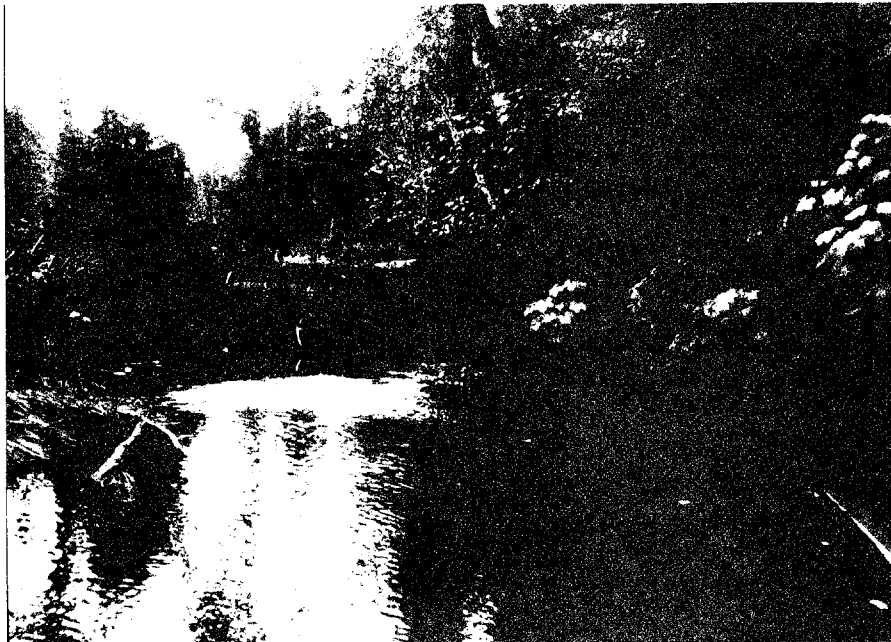
2. Beaver dam (2.0 x 25m) Section 4: 50m.

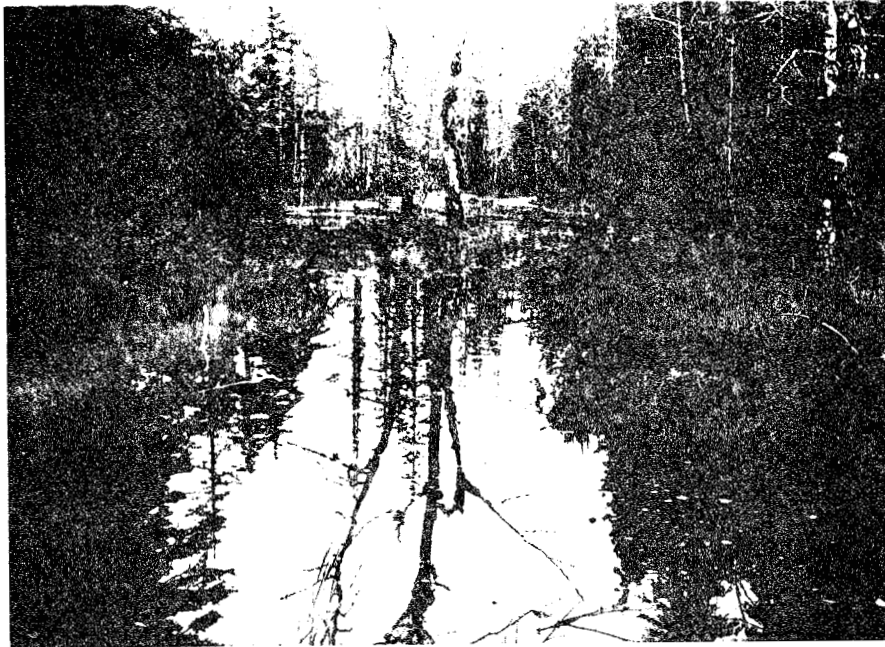
1. A large beaver system just below Survey Area "C".

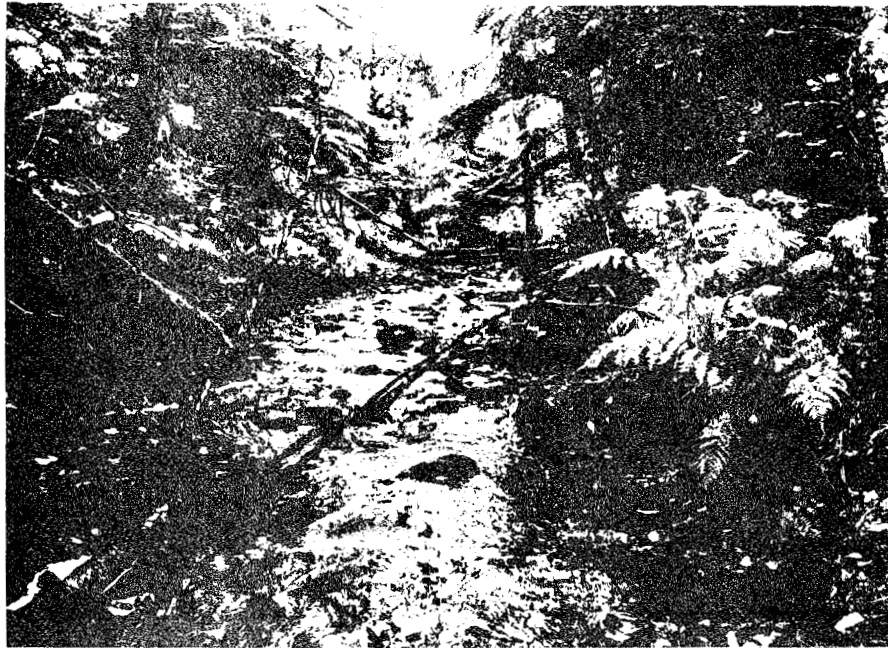
3. Survey Area "C": The substrate size increases to large cobble and boulder composition in Section 5 as the stream travels through a V-notch.

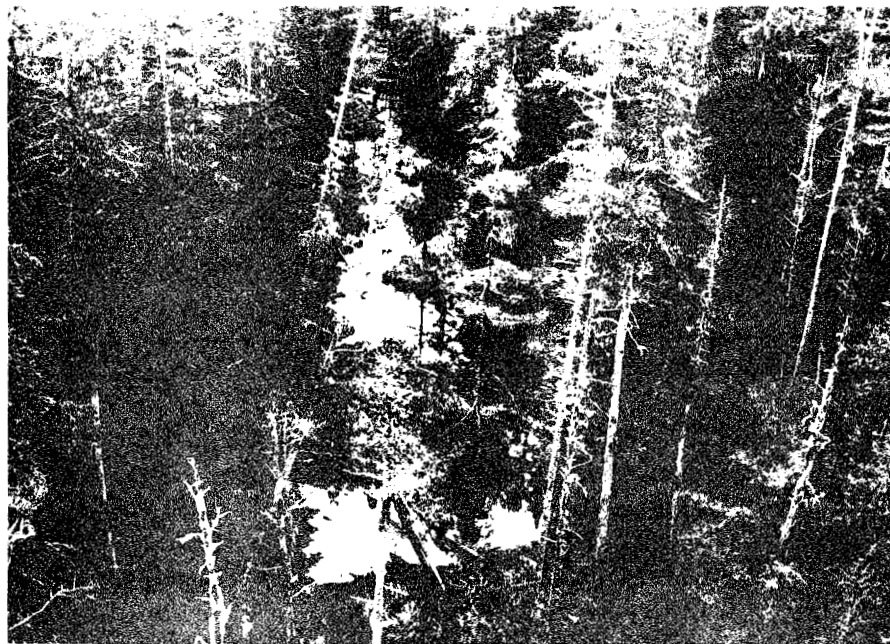
4. Aerial reconnaissance above Area "C" revealed an extensive series of beaver impoundments. No barriers were observed suggesting anadromous use is likely. Note active beaver dam, bottom left.

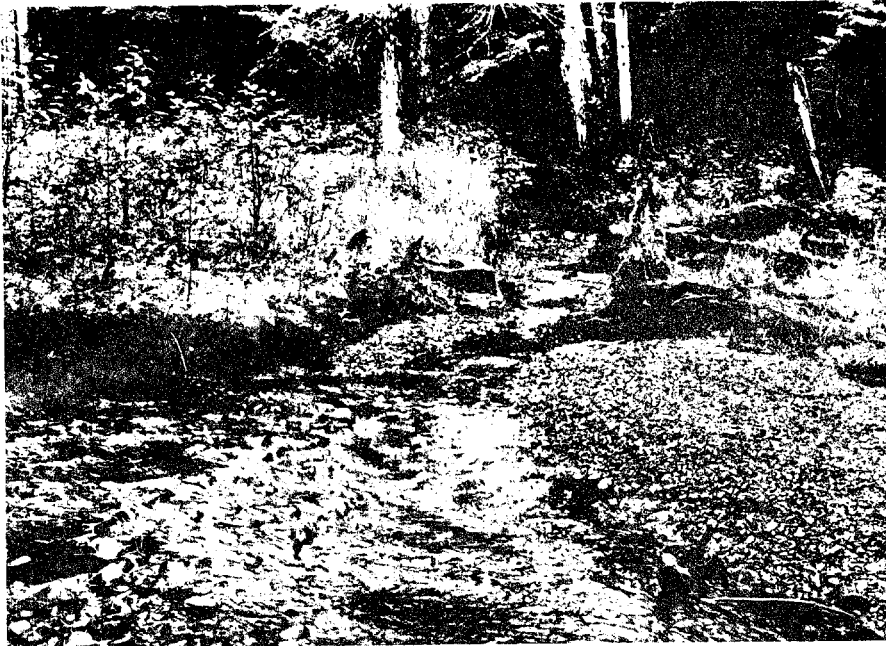
1. The mouth of Survey Area "D" taken from Section 1 of Survey Area "C".

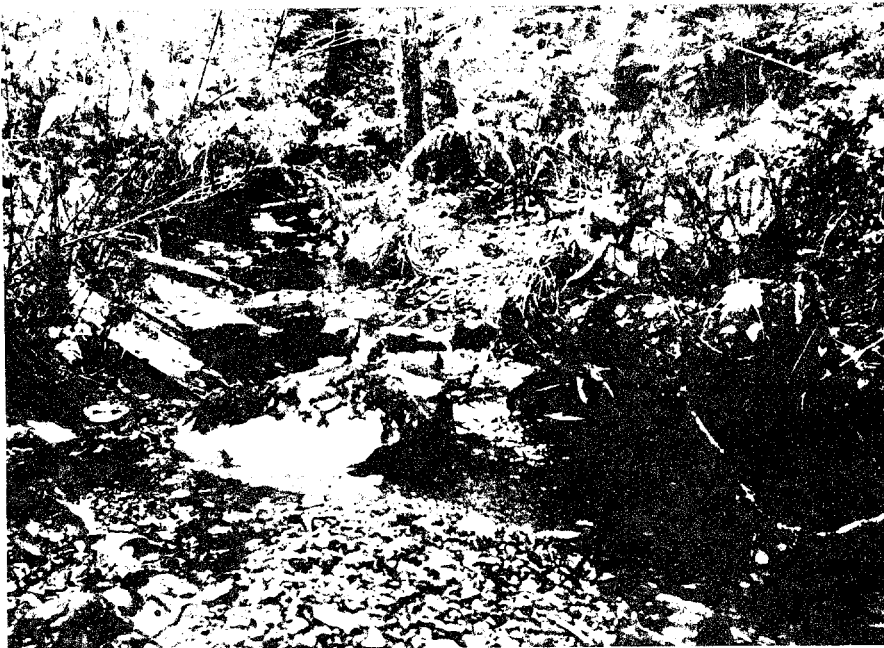
2. Survey Area "D" provides good fish habitat near the confluence but soon deteriorates moving upstream.

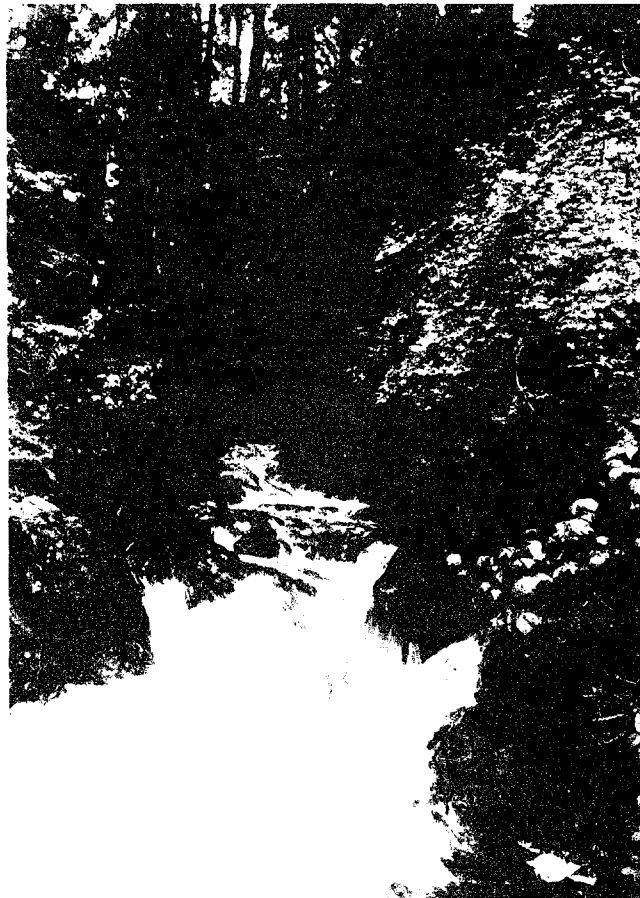
2. A steep V-notch area forms a cascading stream in Section 2.

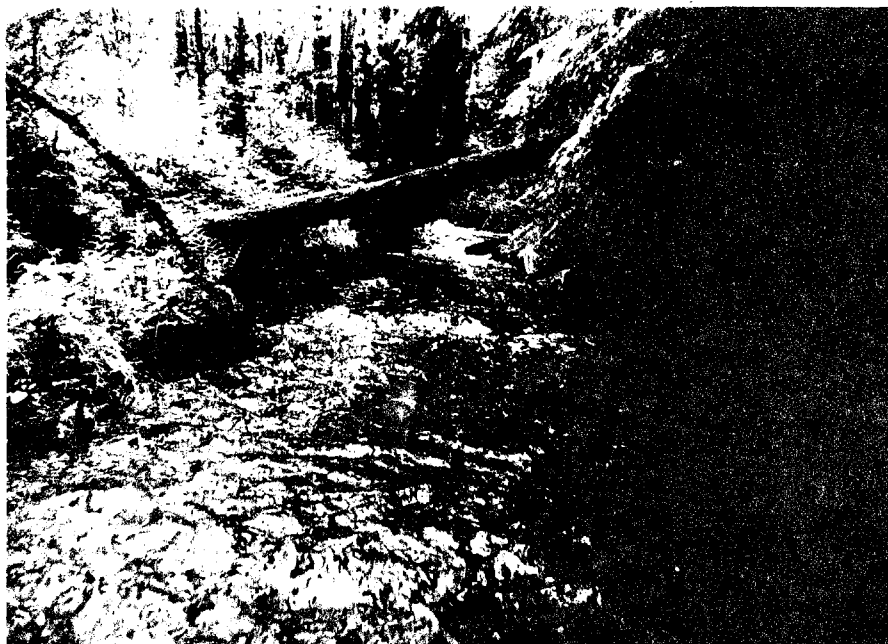
3. Section 6. A large riffle area creates good ASA.

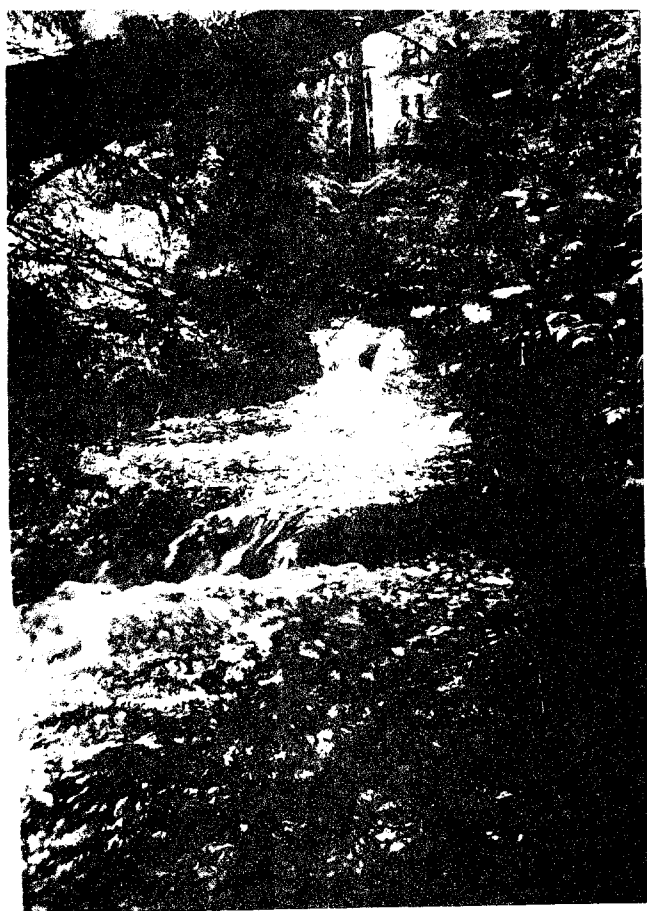
4. Section 13. A steep, muskeg area produces poor fish habitat.

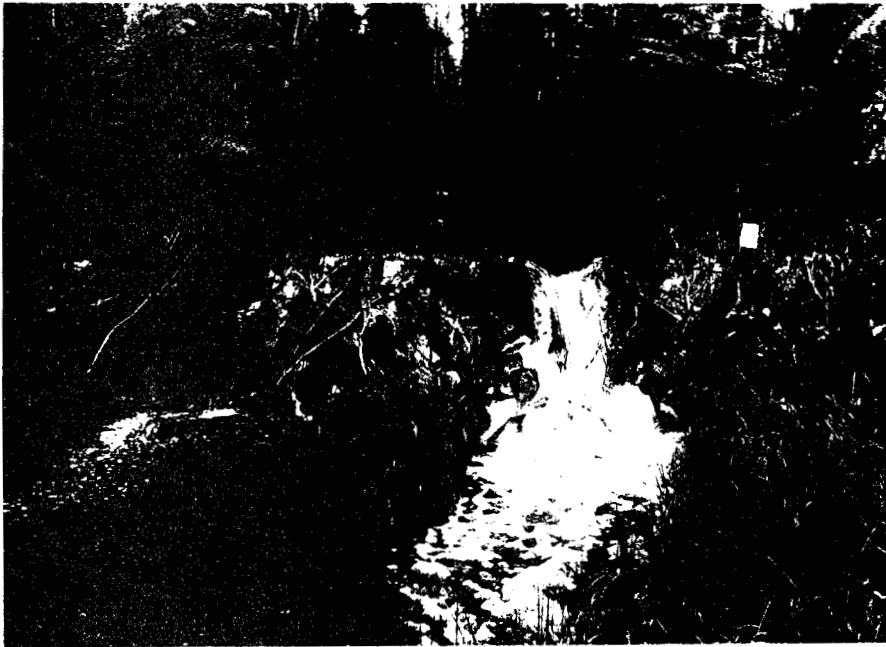
5. 1.5 m high beaver dam at end of Section 16.

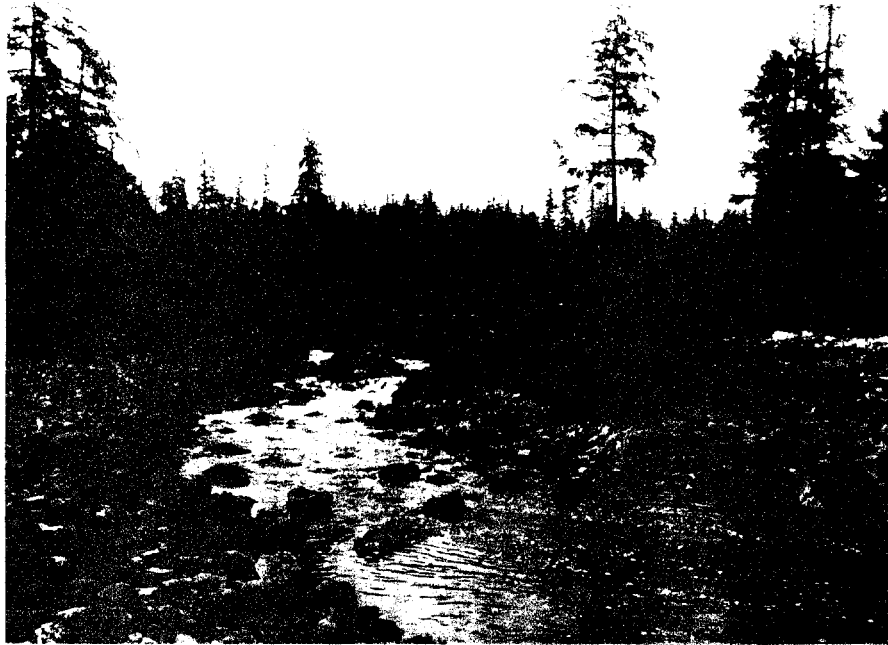
1. ITZ with boulder/cobble substrate and no ASA.

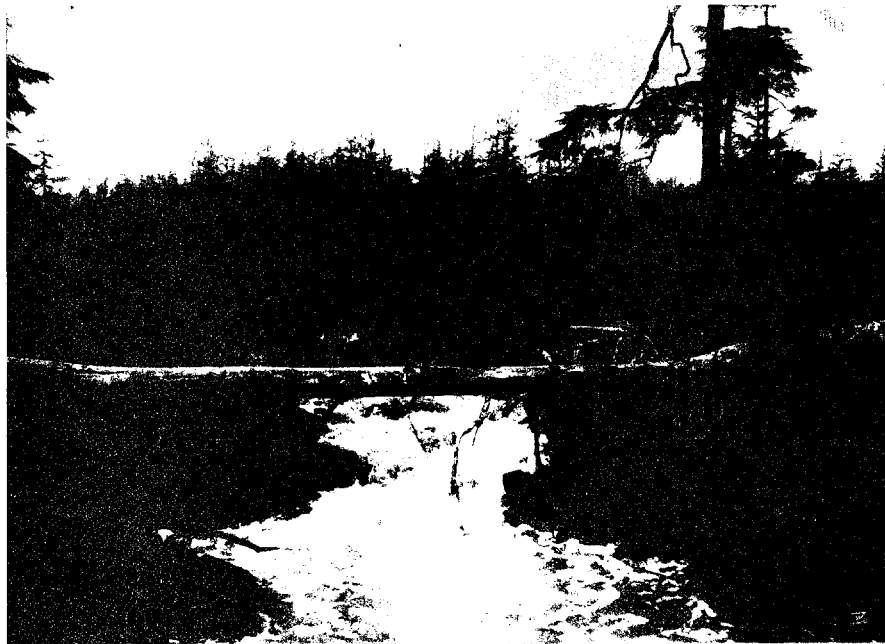
2. Mouth of stream with tidal falls. Harvested unit on both banks.

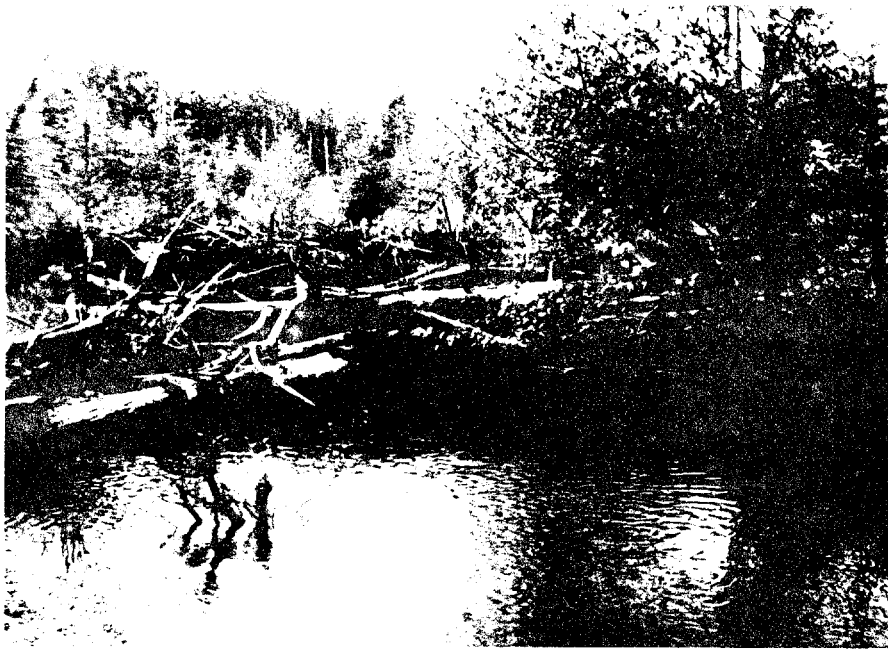
3. Beaver dam at Section 2: 60 m.

Reconnaissance Above Dam: At 40 m upstream, another beaver dam (2.0 m high) is located, forming a pond for 160 m. Stream resumes flow at 4% gradient within a bedrock V-notch. Stream course is still within unit at this point, and consequently many debris jams present. No salmon fry were observed above Section 2: 60 m.

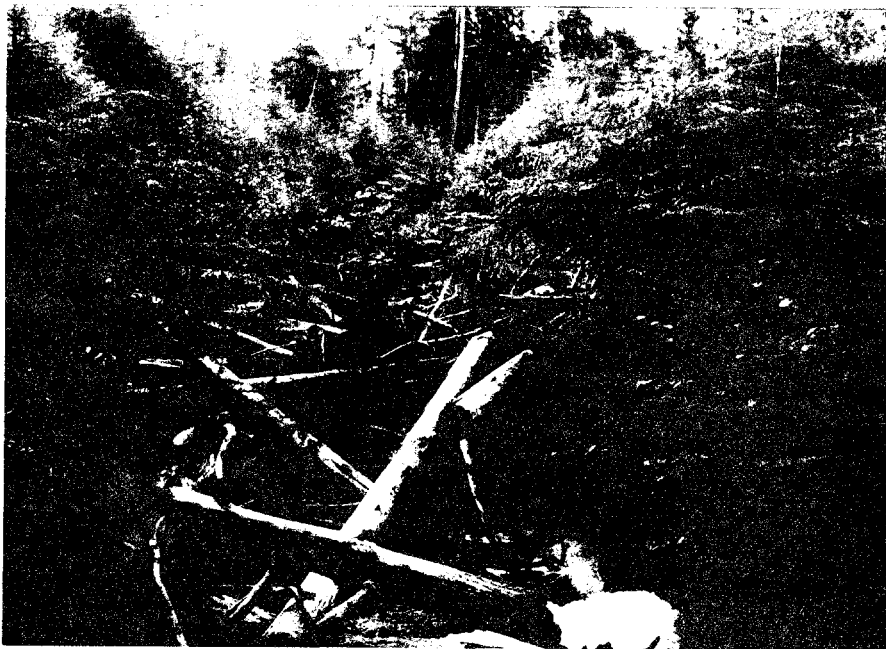
4. Debris jammed V-notch located within unit above beaver pond.

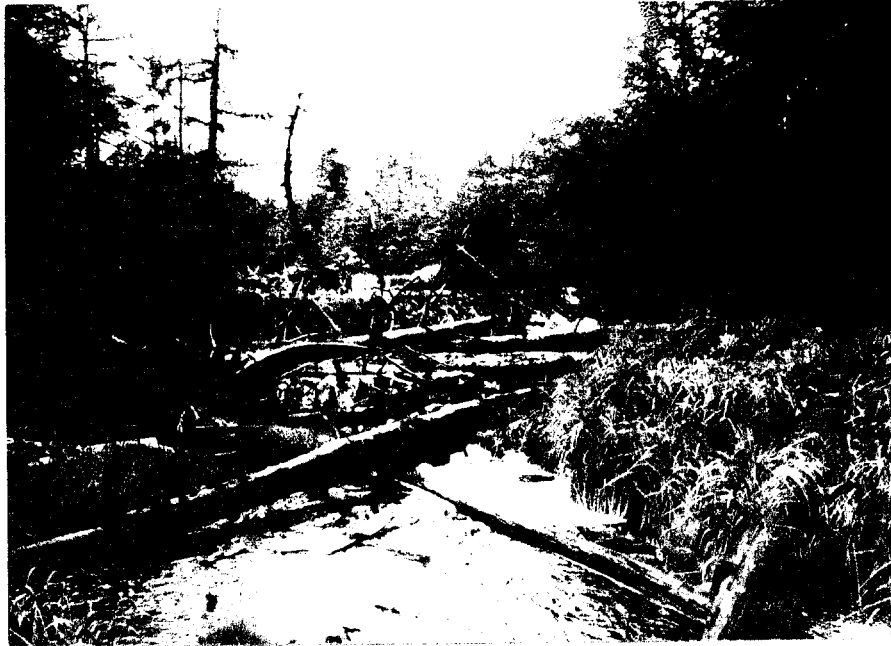
1. Mouth of stream with successive beaver dams forming pond extending into harvested unit.

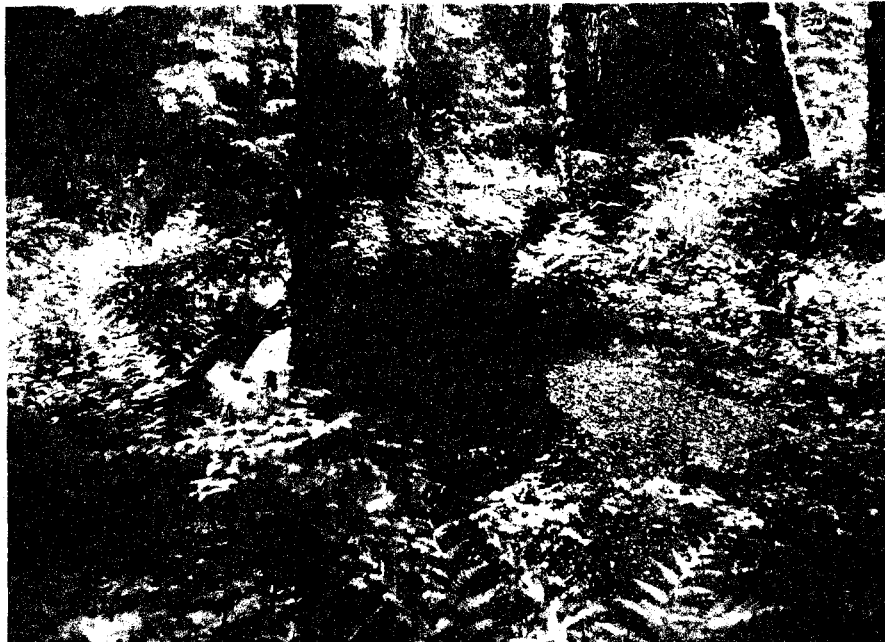
2. Section 4: Typical section in lower reach; excellent spawning riffles, common undercut banks, and abundant overhanging vegetation.

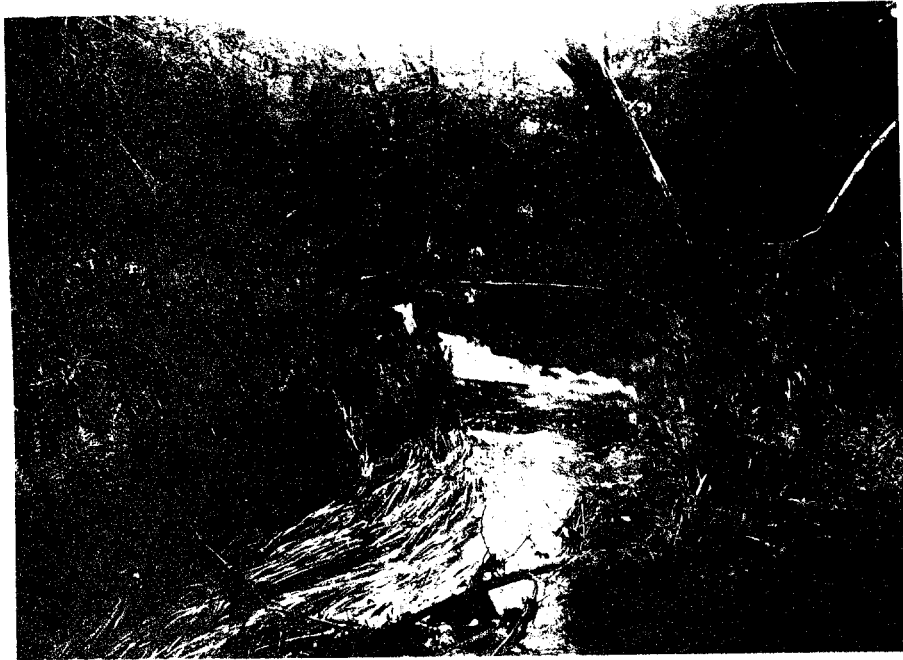
3. Section 7: Channel enters meadow becoming deep and slough-like. Vascular plants abundant, substrate primarily muck/fines.

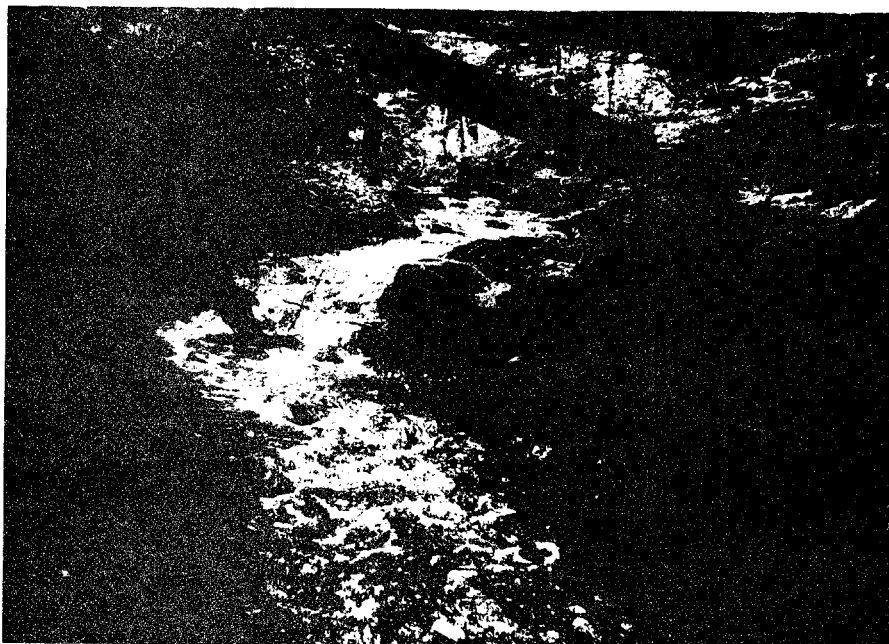
2. Section 1. Cascade area. No ASA.

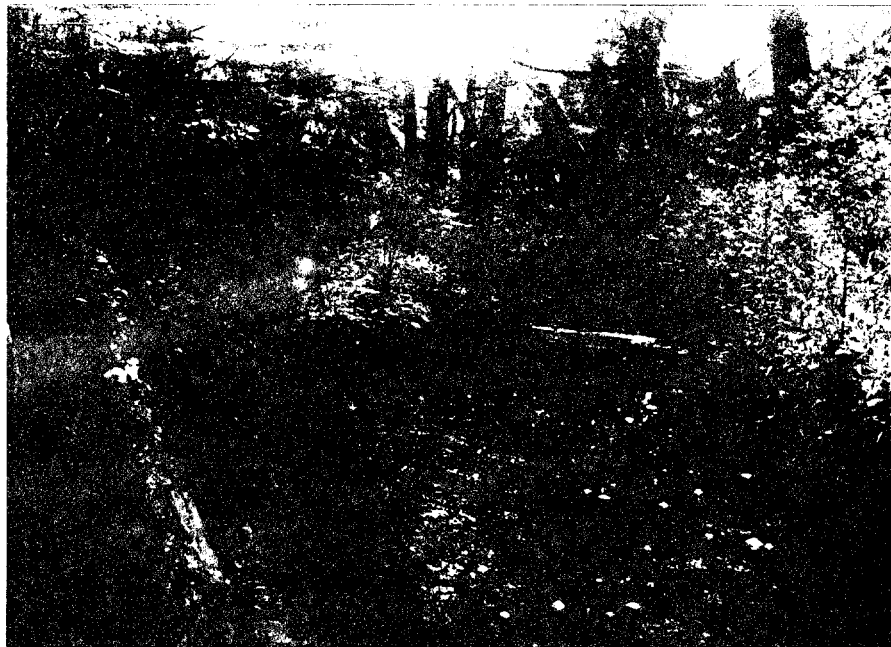
3. Section 3. Good rearing. Fair ASA.

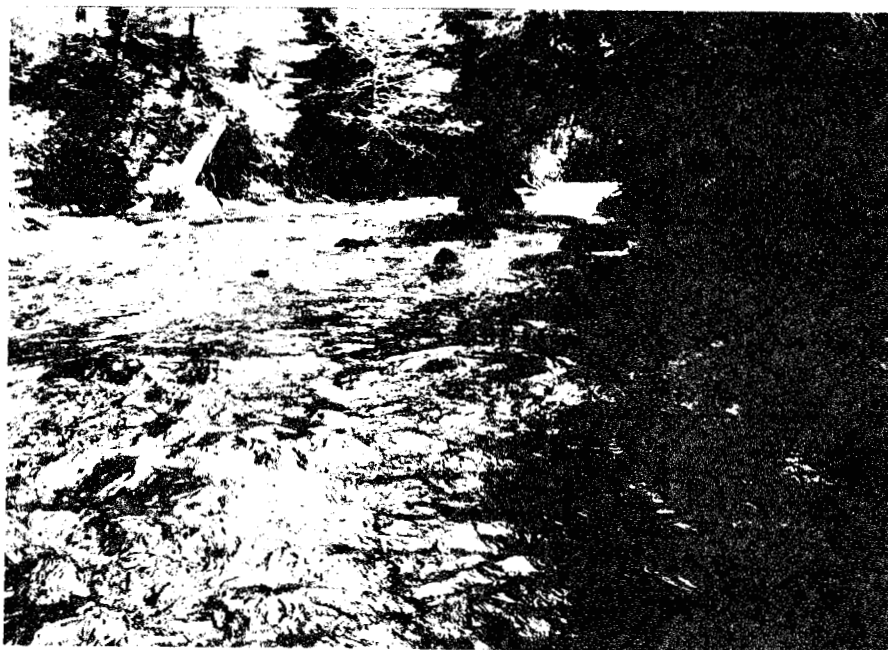
2. Section 4: Deep, fast water over bedrock and boulder substrate.

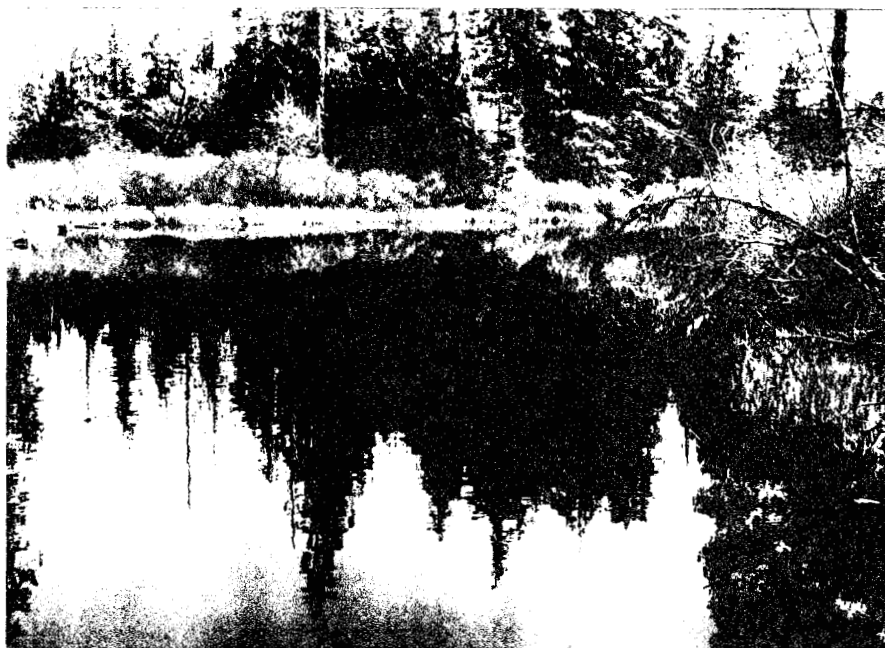
4. Section 7: Showing "slough-like" area below lake.

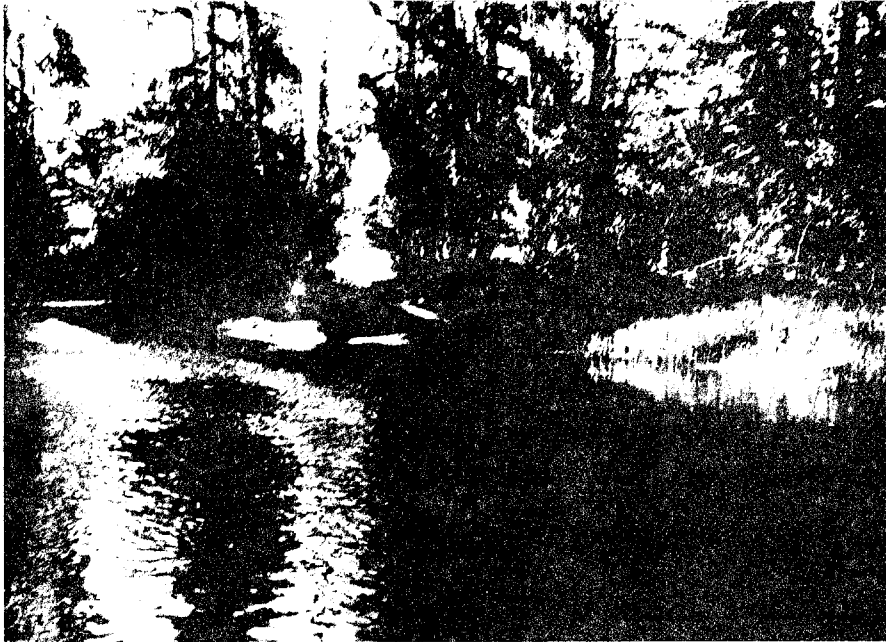
7. End of Reach 1; Survey Area "B": Right Fork. Stream course and Reach 2 to left; beaver system to right.

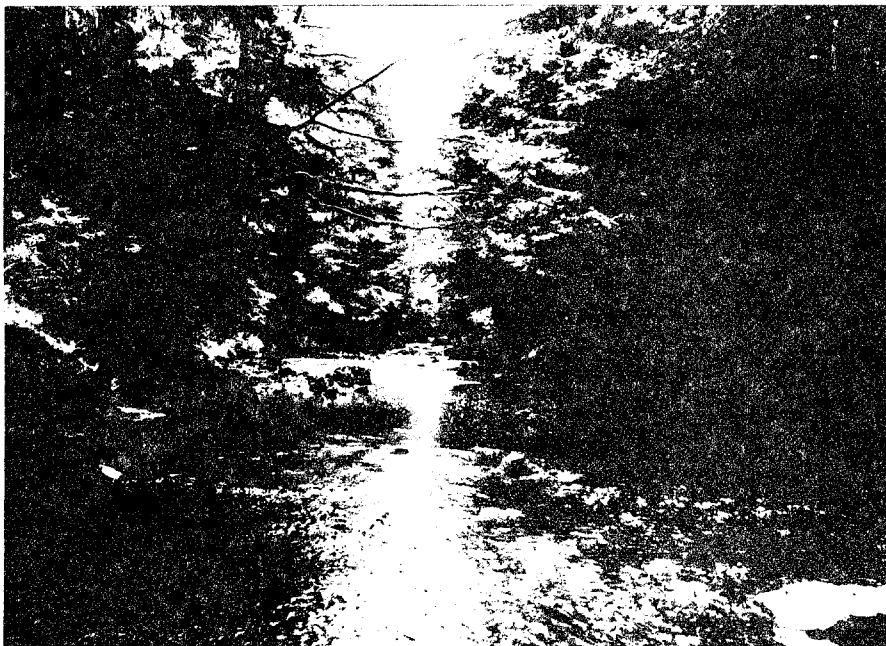
Increased gradient and substrate size (mostly cobble) brings ASA up considerably (especially for coho) with a riffle/pool ratio of about 4:1. Streamside banks have begun to steepen, and the streamcourse is gradually becoming more channelized. Predominantly trout fry were observed in this reach of 400 m.

8. Reach 3; Survey Area "B": Right Fork. Riffle area between steepening banks.

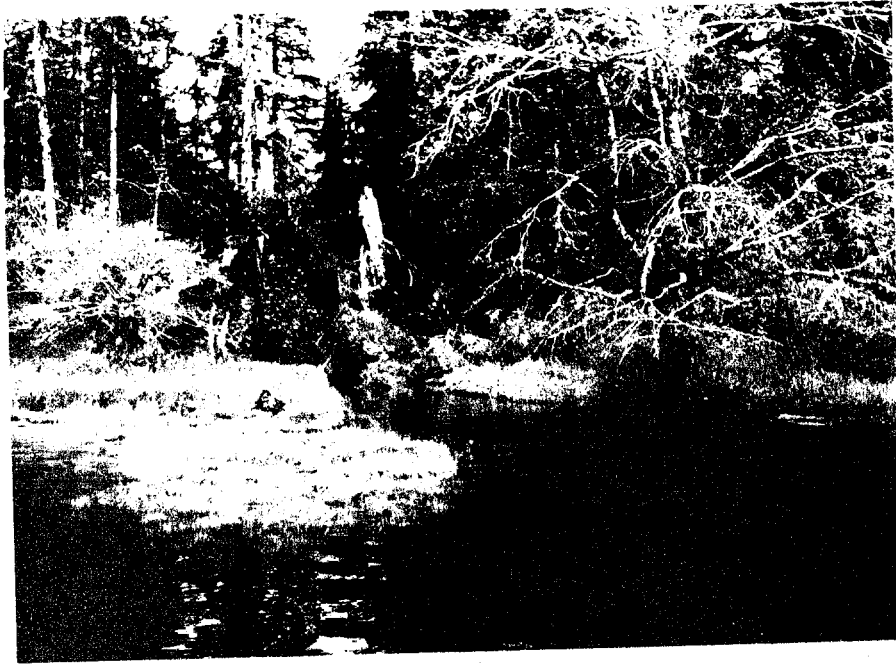
1. Mouth of stream with backwater area from lake.  
Blowdown visible left side.

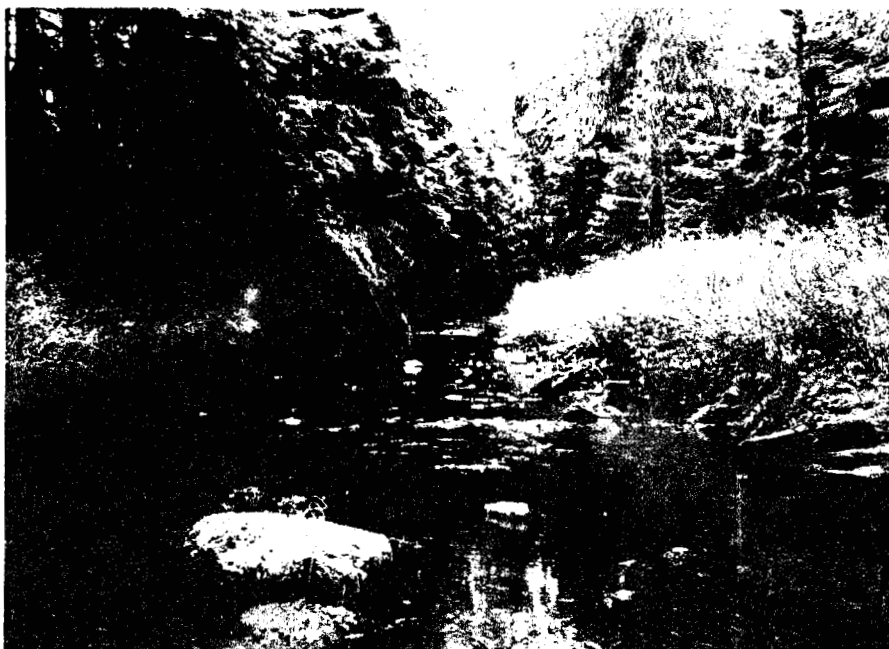
3. Reach 3 habitat with stream flow channelized between steep banks over cobble substrate.

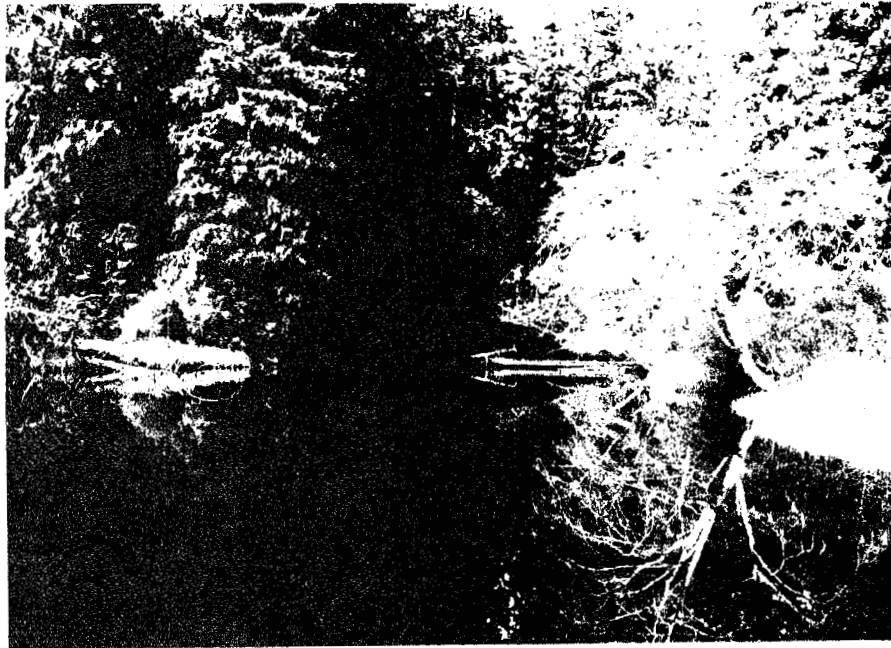
The initial reach (300 m) is characterized by the backwater influence of Salmon Bay Lake as evidenced by the low gradient and resulting low velocity throughout the reach. The extent of this flatwater influence would vary with lake water levels. The substrate is largely loose gravel providing excellent spawning habitat, especially for sockeye due to the lower level of aeration. This reach is possibly temperature sensitive for the same reasons: low gradient, low velocity and shallow water depth.

Continuous undercut banks, along with moderate amounts of cross-stream windthrow, create good rearing habitat. Abundant coho fry were observed as well as eleven adult steelhead.

1. Mouth of stream showing backwater influence of a lake;  
characteristic of Reach 1.

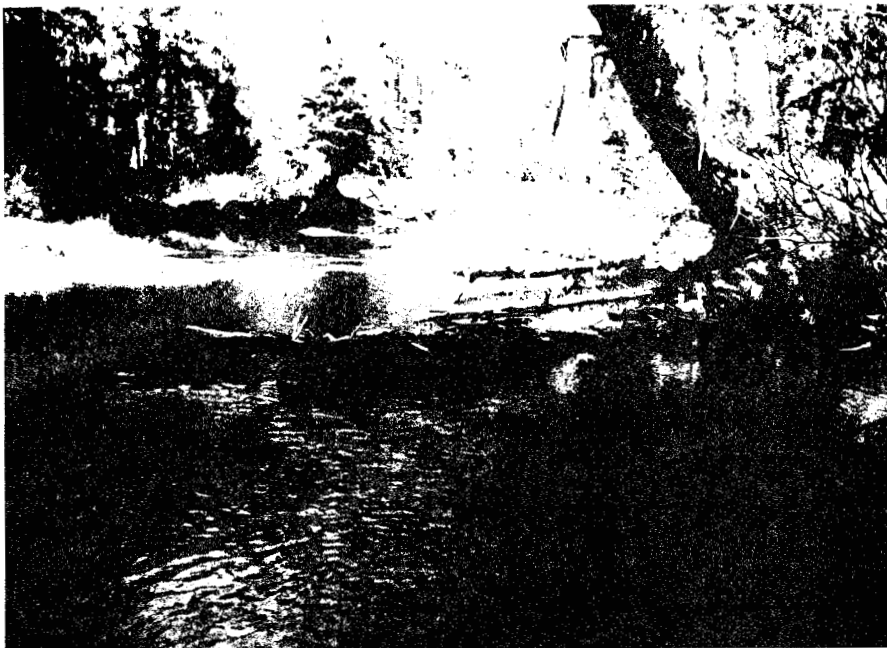
3. Section 5: Showing excellent pool/riffle ratio.

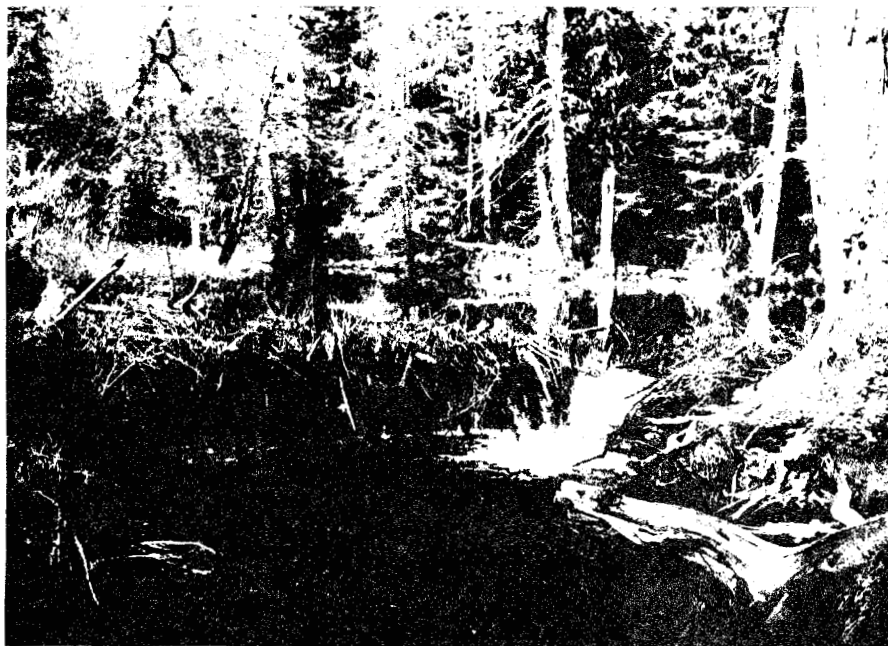
4. Beaver dam at beginning of Section 6.

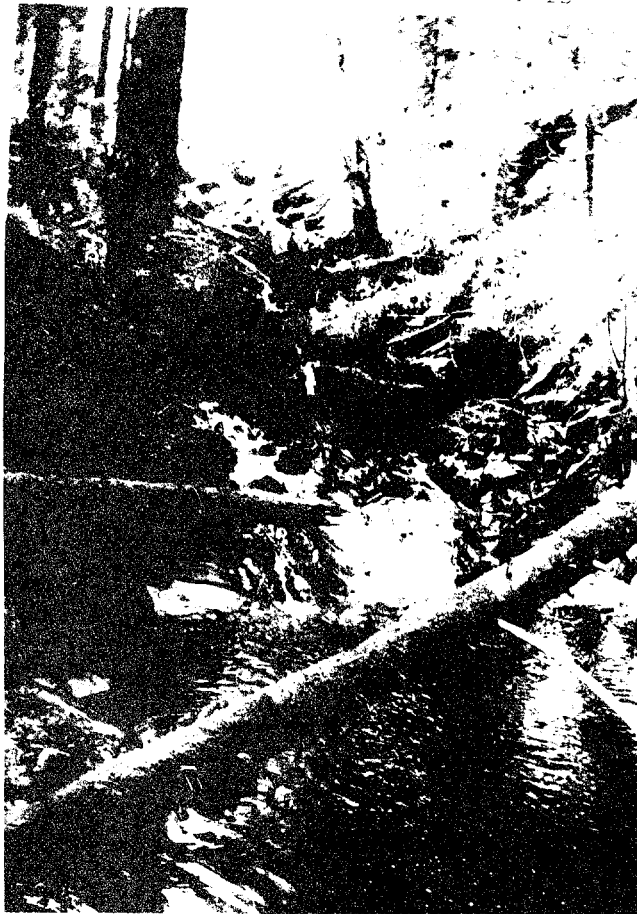
The reach ends with a 20 m barrier falls over bedrock. Reconnaissance above the falls found habitat unsuitable for the possibility of enhancement.

5. 20 m barrier falls at the end of Section 10. Terminate main stem survey.
